Cameron Peak Fire at Shambhala Mountain Center

Fire Effects in Forest Restoration Treatment by Fort Collins Conservation District

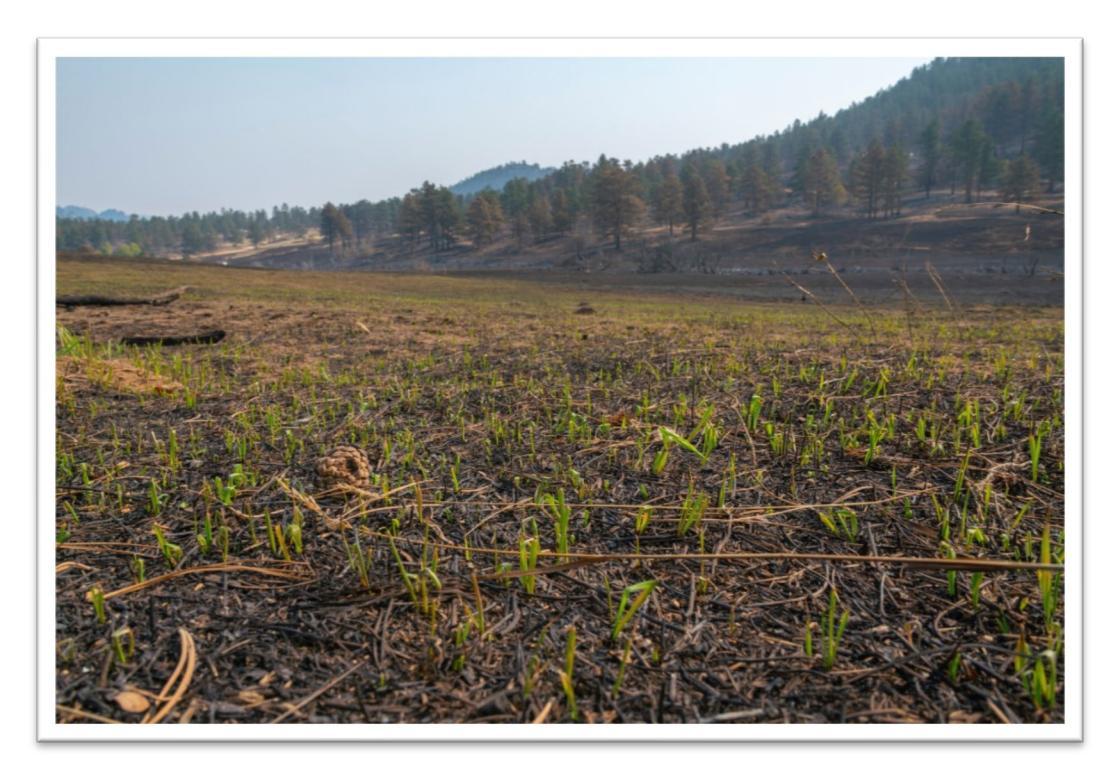
SMC's central meadow in the foreground. This photo was taken one week after the fire swept through. The soil burn severity was very low, encouraging new grass growth almost immediately.

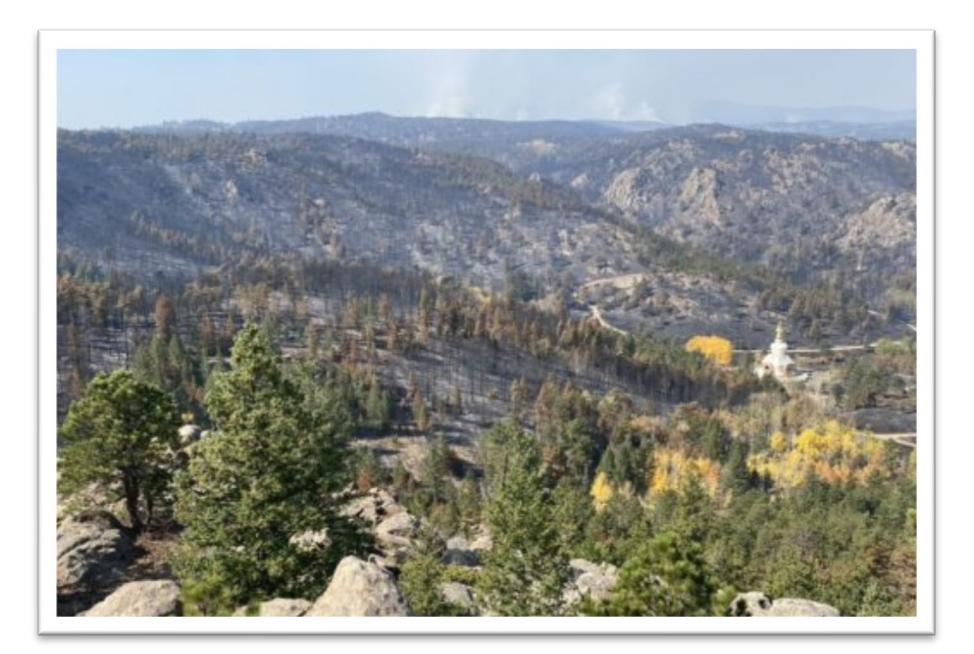
The slope and ridgeline in the background of this photo demonstrate a high-severity burn area on SMC and adjacent National Forest. The fire behavior on these slopes can be attributed to high fuel-loading and wind speeds.

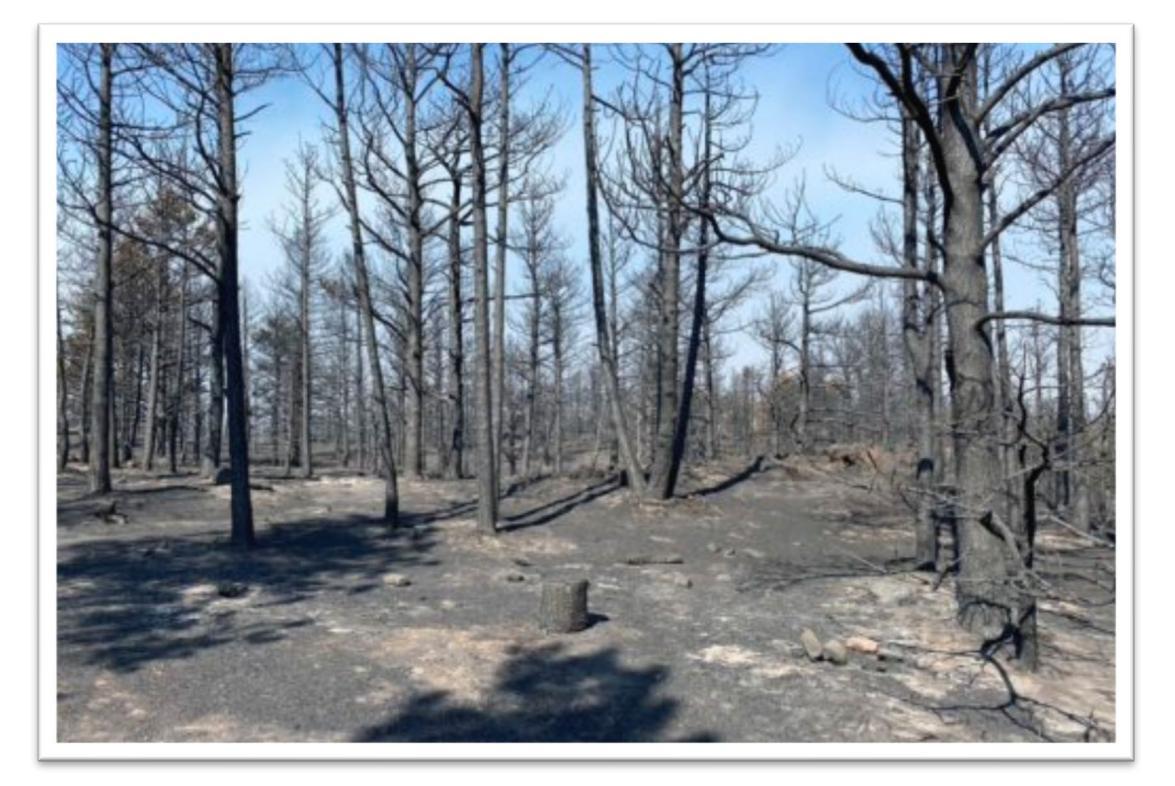
An area on SMC's property that experienced high burn-severity. This is an area that was scheduled for a restoration treatment, but was not treated in time. High tree densities and strong winds contributed to the fire effects on these acres.

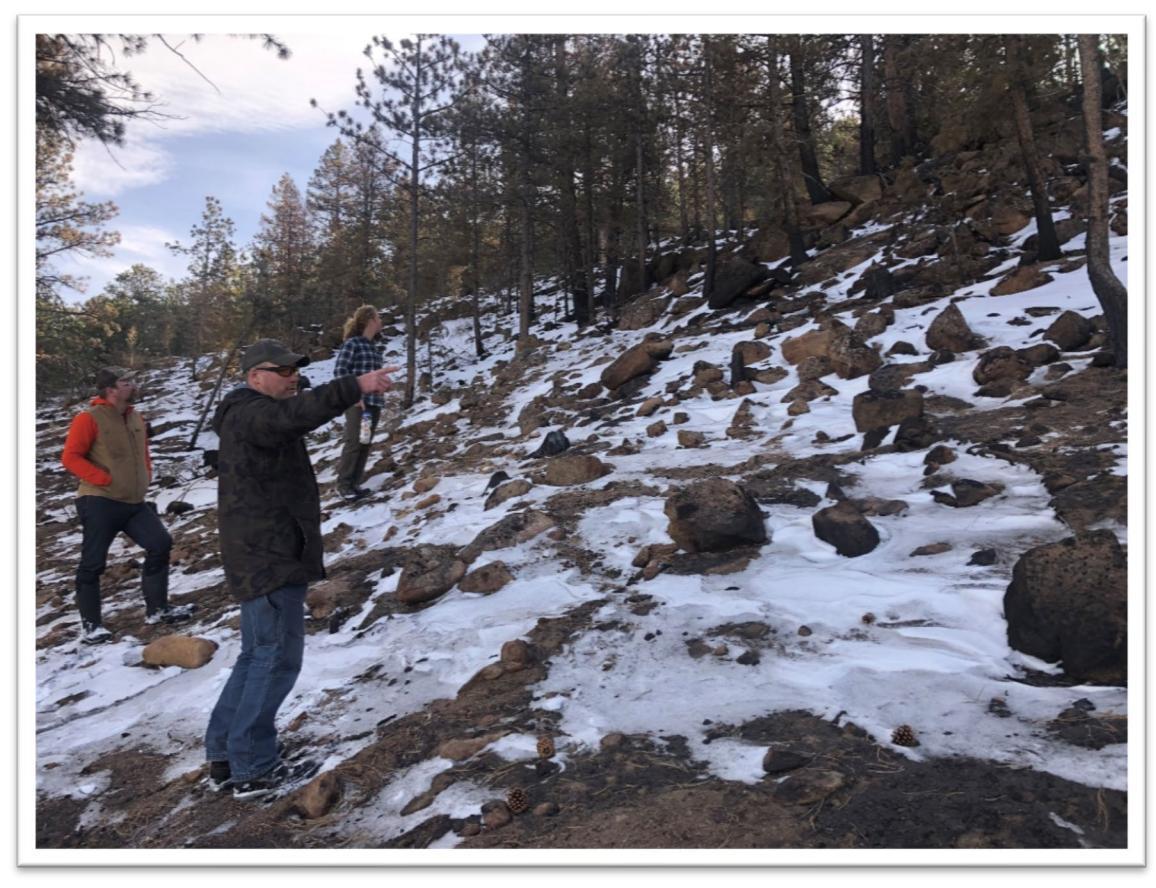
A rocky, unproductive hillside with minimal surface fuels, despite the high tree density. The fire did not burn much of this hillside, despite burning through the treated area below.

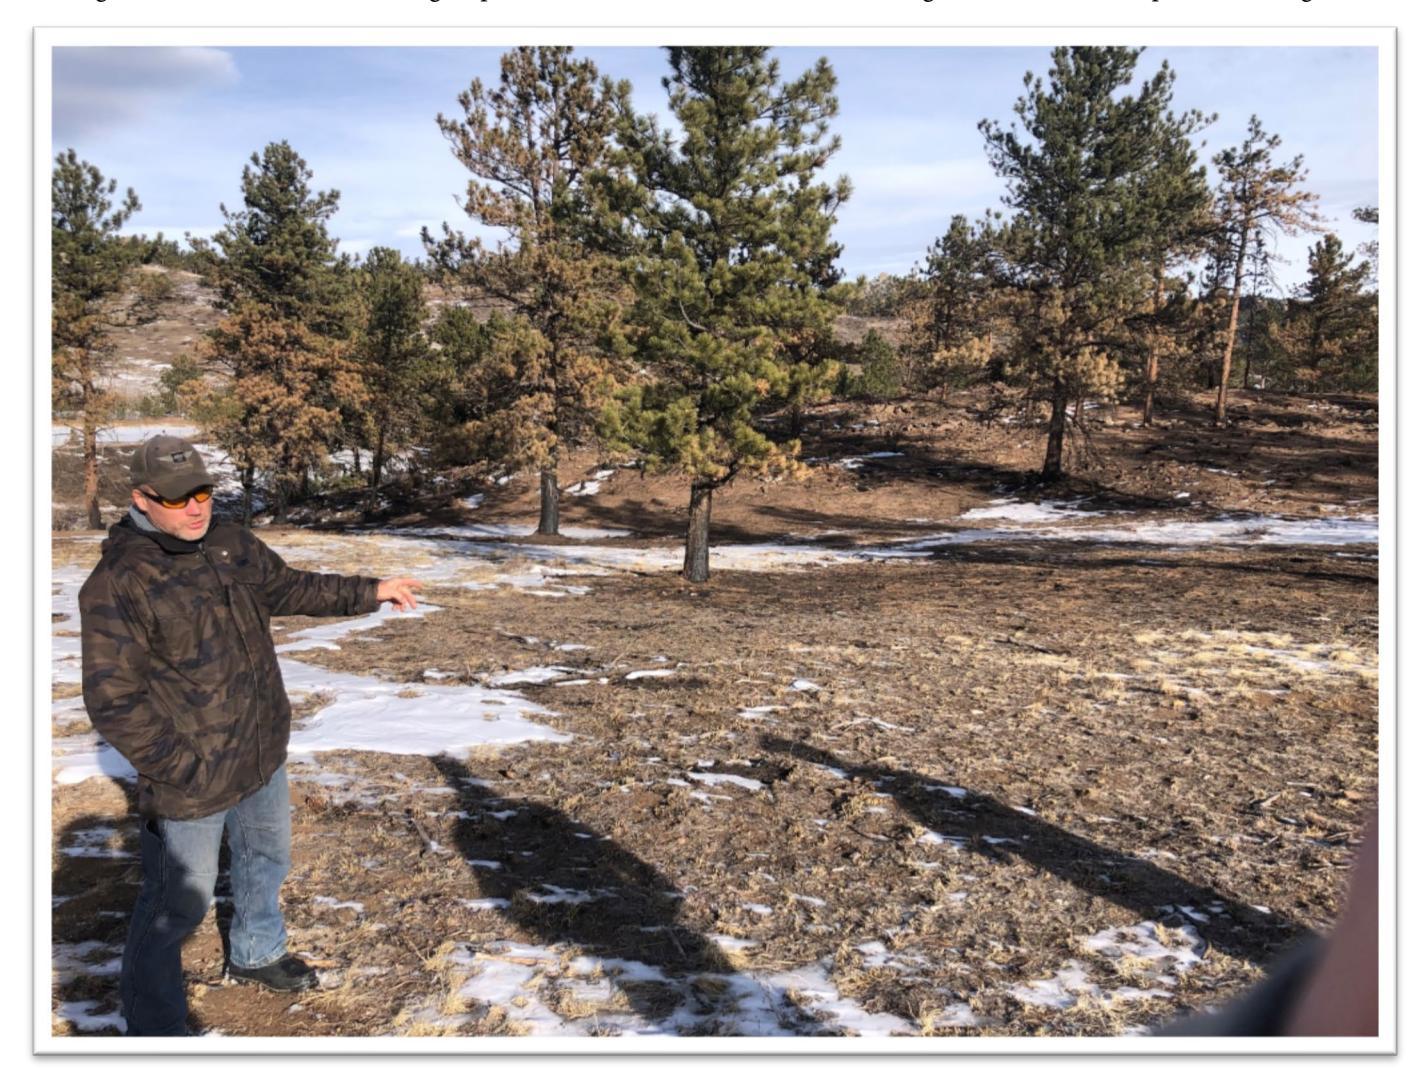
This stand was treated in 2018 by a ground-based heavy mechanized forest restoration approach. The fire largely stayed on the surface, while occasionally jumping into a tree to scorch it. We expect some mortality in this stand. The surface grasses, needle-cast, and shrubs contributed to the scorching of trees.

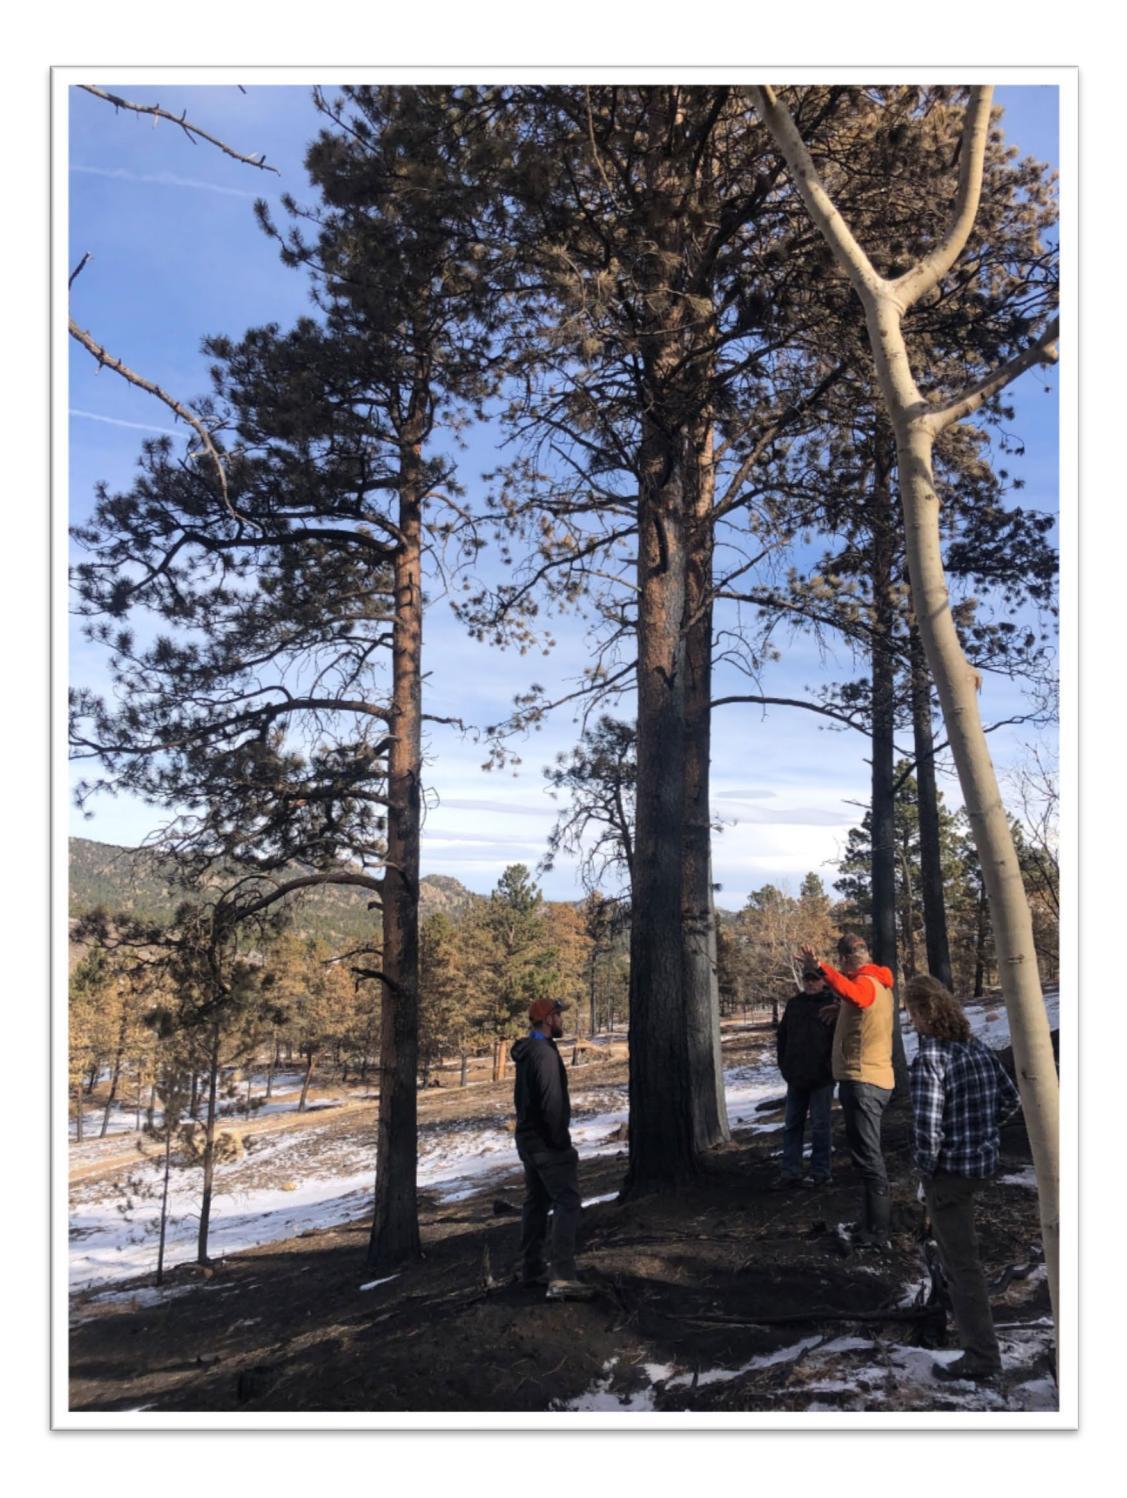
This photo shows a group of five ponderosa pines that experienced heavier scorching in a treated stand. Where you see the group of people standing is where there had been a dense cluster of deciduous shrubs and trees including mountain maple and aspen. The density and dryness of those fuels most likely contributed to these pines scorching more heavily than surrounding trees.

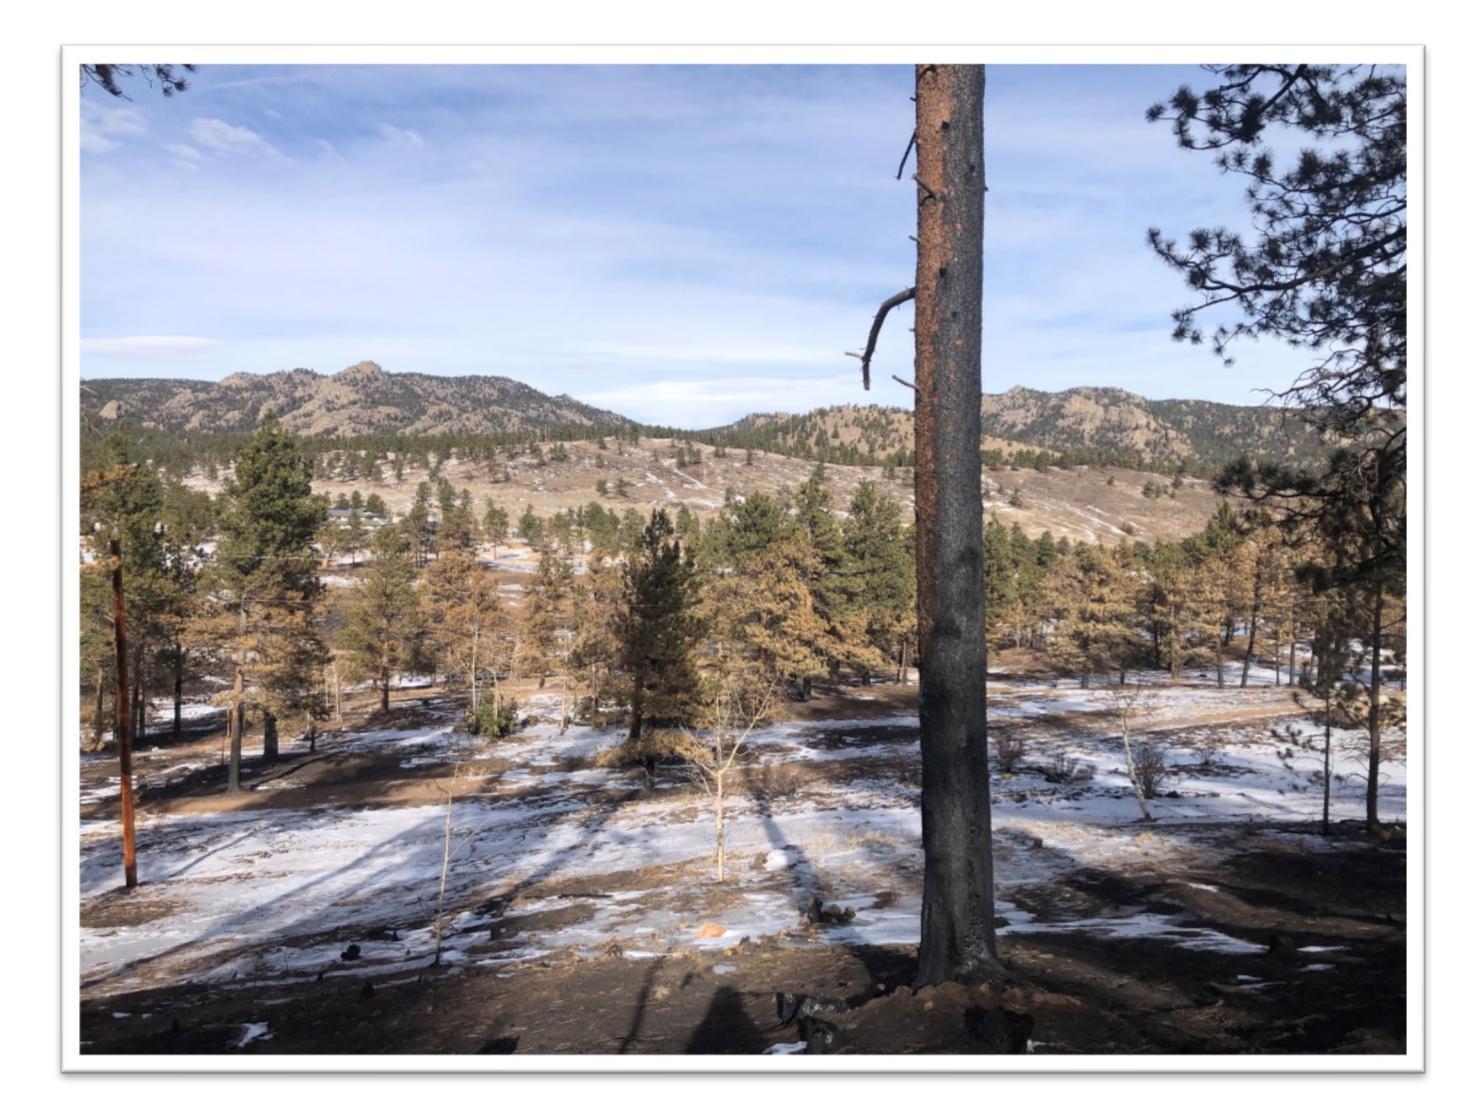
This stand was treated in 2018 by a ground-based heavy mechanized forest restoration approach. The fire largely stayed on the surface, while occasionally jumping into a tree to scorch it. We expect some mortality in this stand. The surface grasses, needle-cast, and shrubs contributed to the scorching of trees. Additionally, this stand included 50+ wood tent platforms scattered throughout. The tent platforms contributed to more intense localized fire behavior. We observed that trees downwind of the platforms were the ones with higher scorch and mortality.
