Cameron Peak Fire at Shambhala Mountain Center

Fire Effects in Forest Restoration Treatment by Fort Collins Conservation District

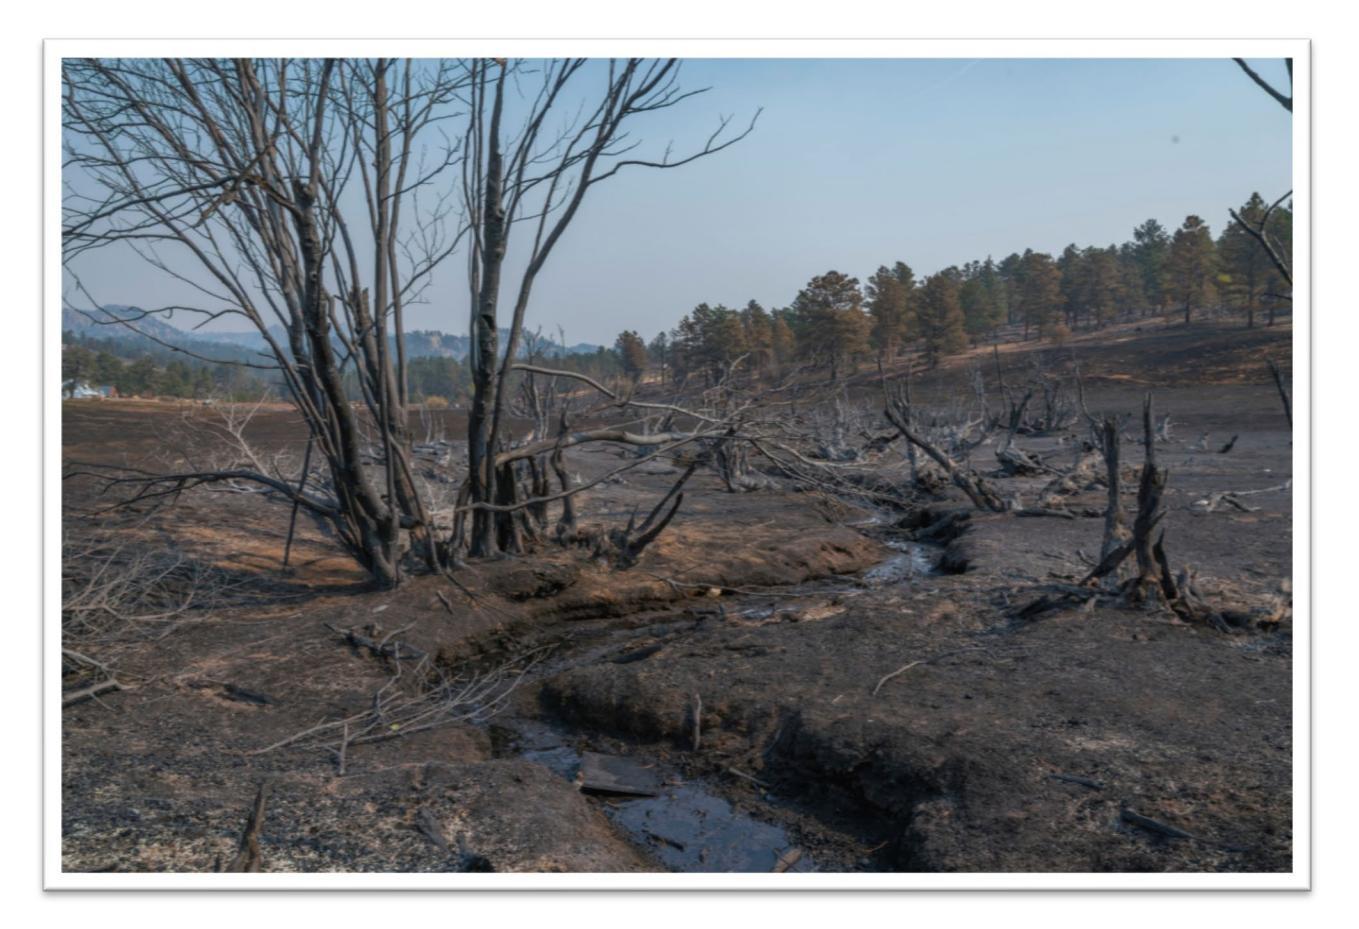
SMC's central meadow and a tributary of the Manhattan Creek experienced fire on September 26, 2020 due to hot and dry conditions combined with 90th percentile fuel moisture conditions.
